ROCKAWAY BEACH WWTF
Rockaway Beach, MO.

September 13, 2007

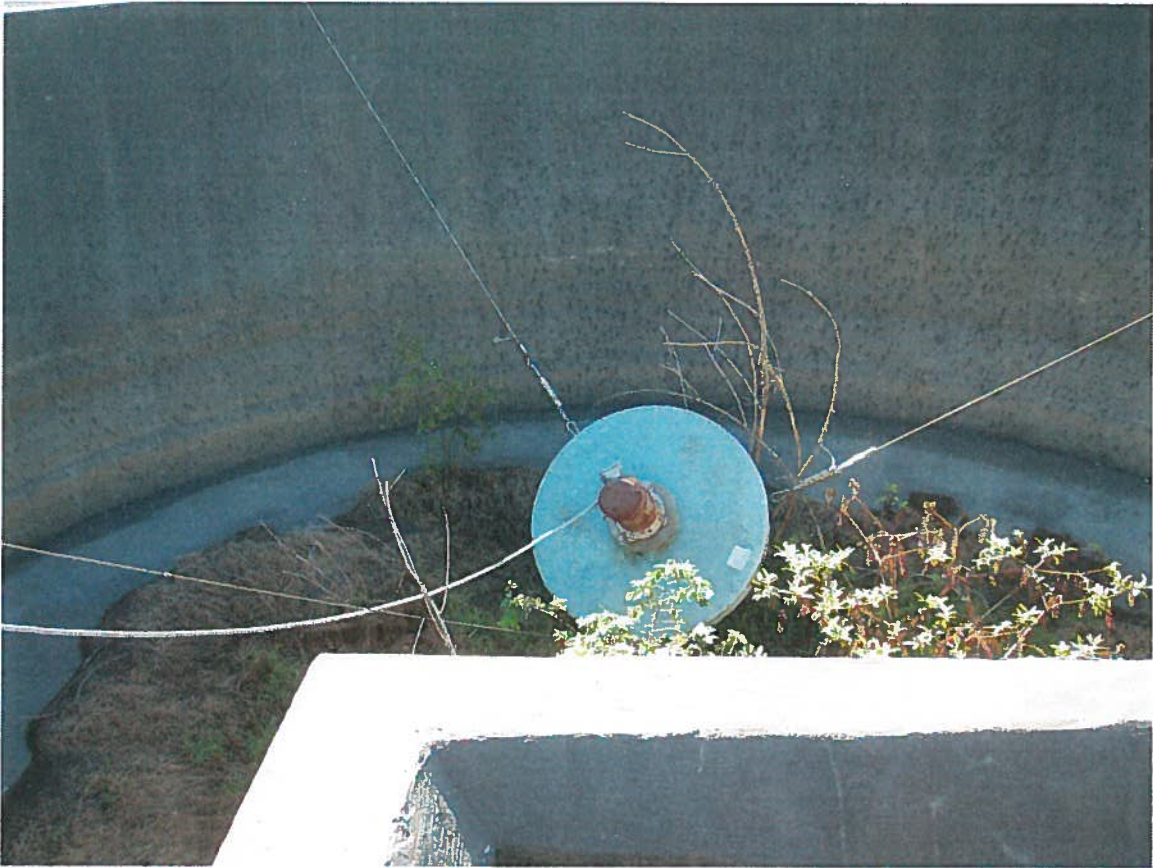
Photo no. 17 This photo was taken from the top of the old sludge storage tank. The vegetation growing in the bottom of the tank is good evidence that the tank is not used for gravity thickened sludge storage. The floating aerator is visible in the bottom of the tank.

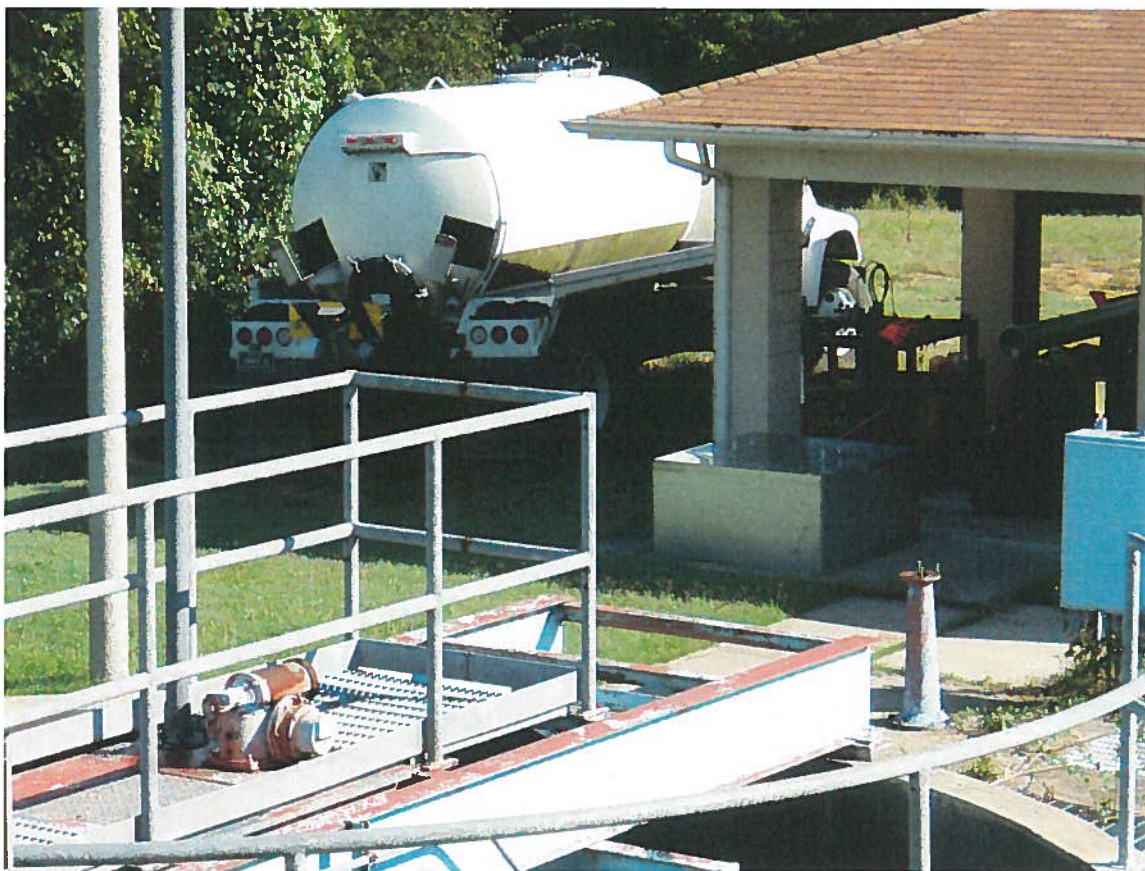
Photo no. 18 This photo was taken from the old sludge storage tank looking north. It shows one of the old final clarifiers in the foreground and the liquid sludge hauling truck in the upper center of the photo. The truck applies the sludge by spray bar.

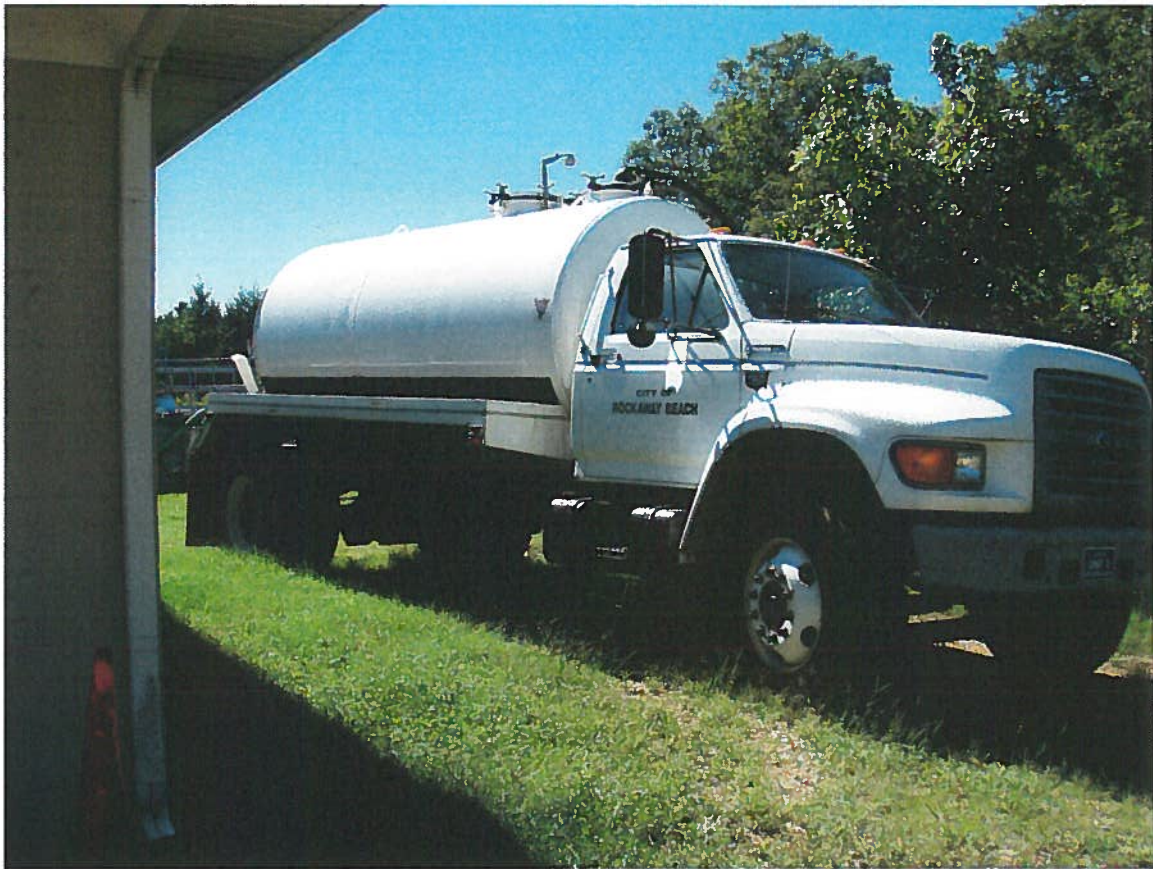
Photo no. 19 This photo shows the city's 2200 gallon liquid sludge haul truck. It is parked on the northwest side of the laboratory/control building. Much of the sludge hauled is done by a contract employee using this truck.

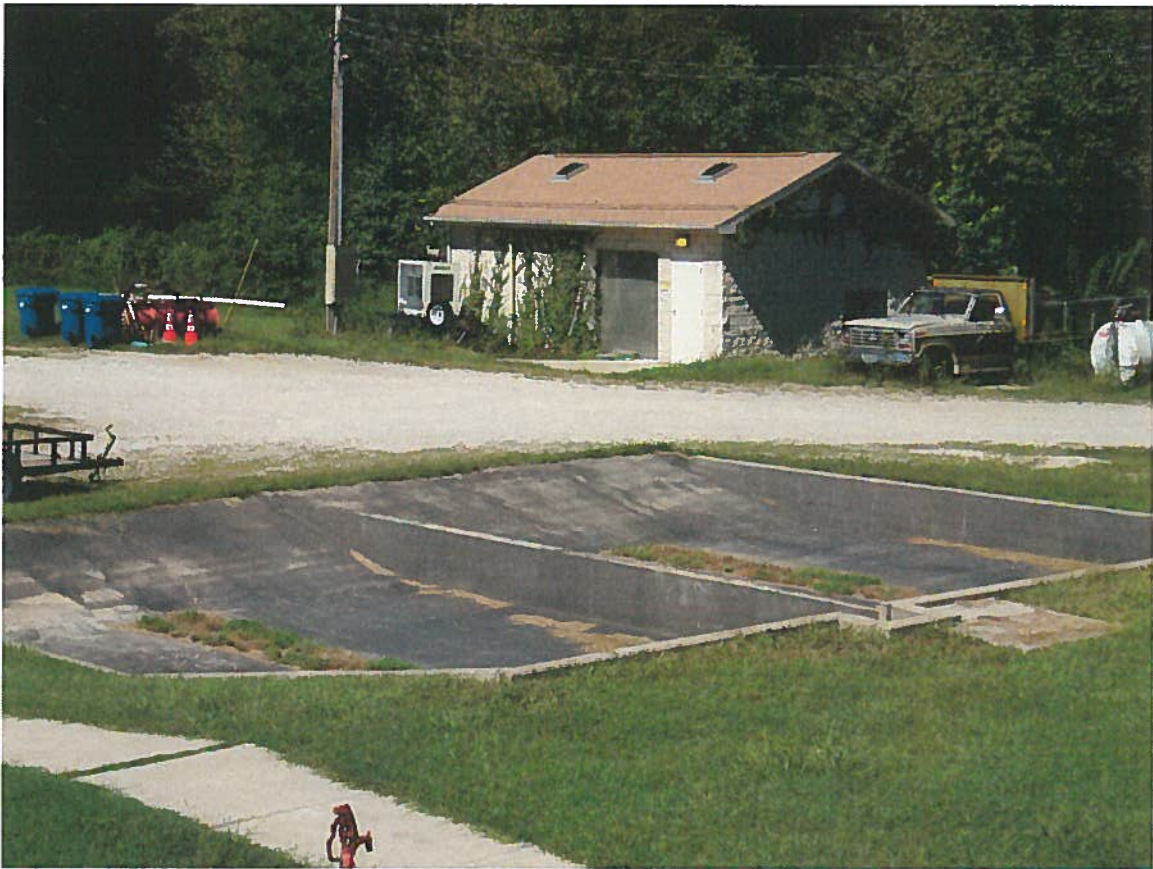
Photo no. 20 This photo was taken looking north from near the sand filter building. Located in the foreground are two paved drying beds. Bed drainage would be through the grassy strip in the middle of the bed. The raw sewage pumping building is located in the background. The portable generator shown at the left corner of the pump building is not hooked to anything and is not ready to be used.

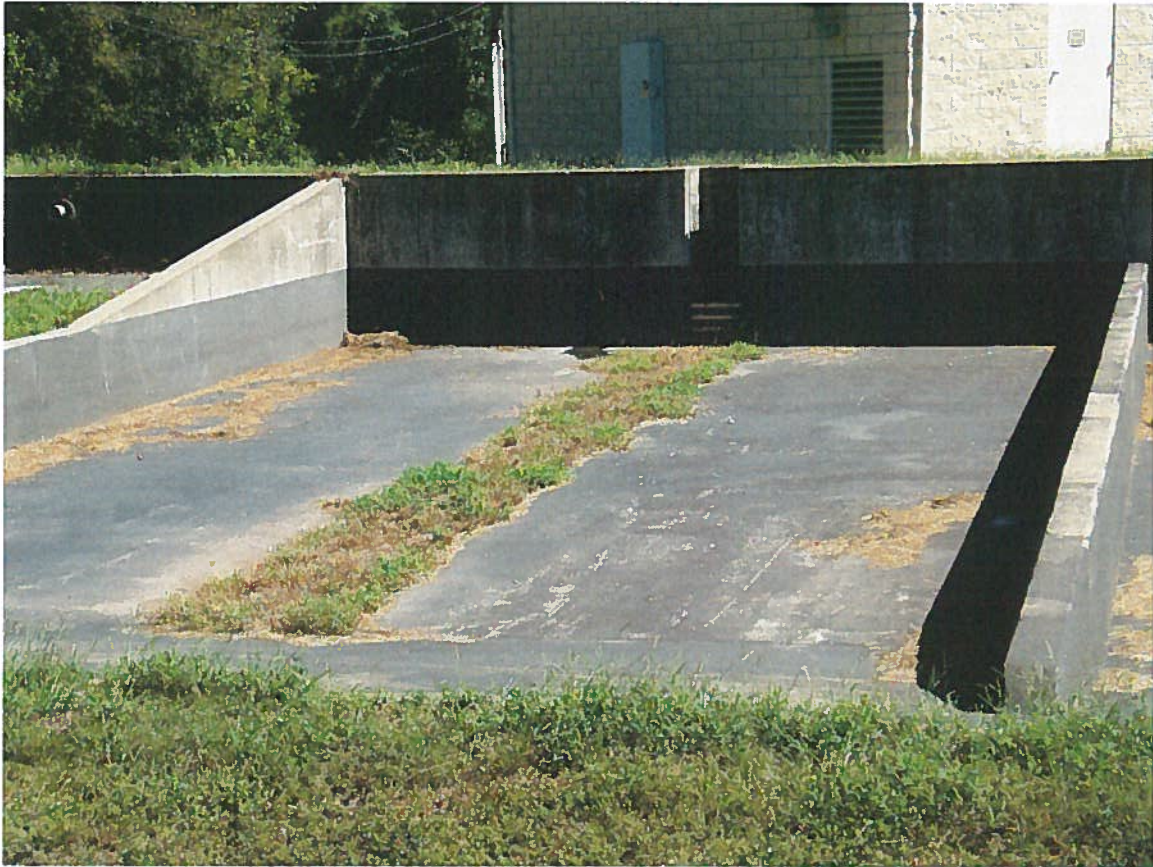
Photo no. 21 This photo was taken looking east from near the laboratory/control building. Located in the foreground are two paved drying beds. Bed drainage would be through the grassy strip in the middle of the bed. The final effluent sand filter building is located in the background.

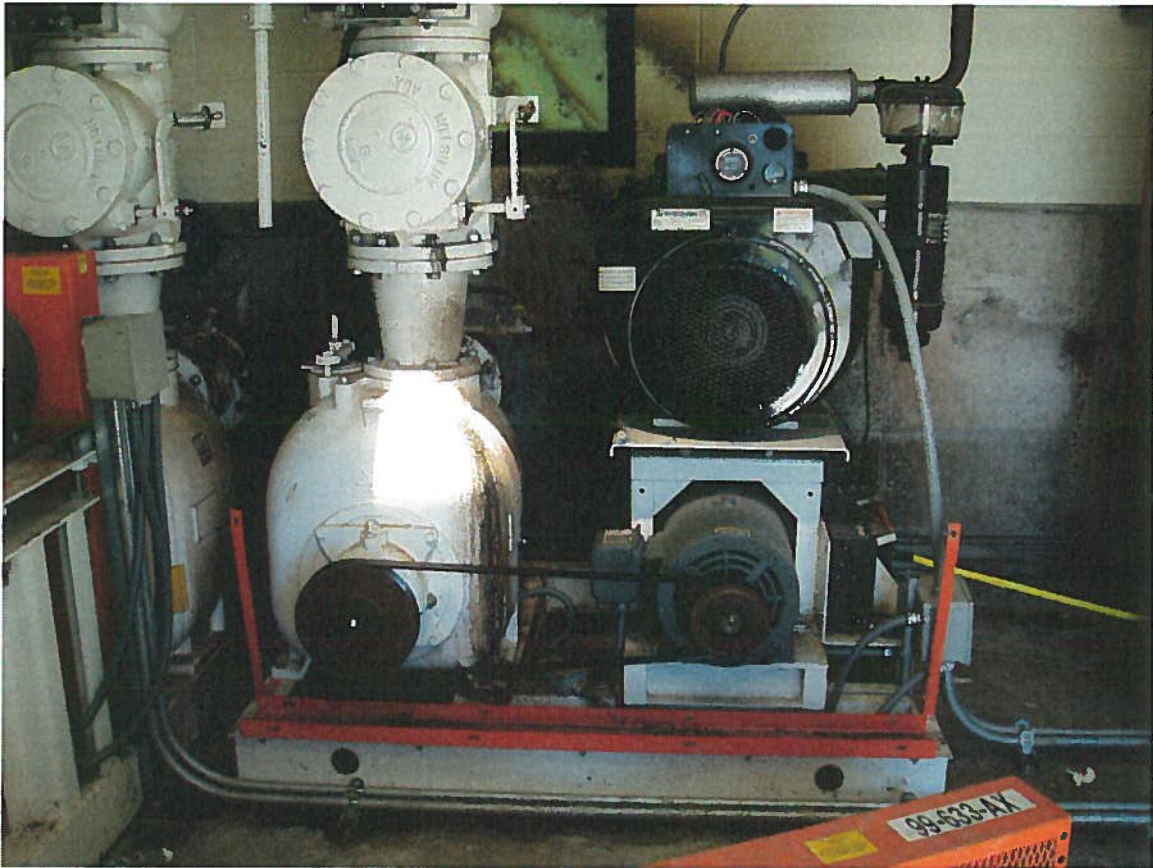
Photo no. 22 This photo was taken inside the raw sewage pump building. Shown is one of the suction lift sewage pumps. Note the missing cover over the drive belt. This is a safety hazard. This unit also has a propane operated standby generator for firm pumping capacity in the event of a power failure.

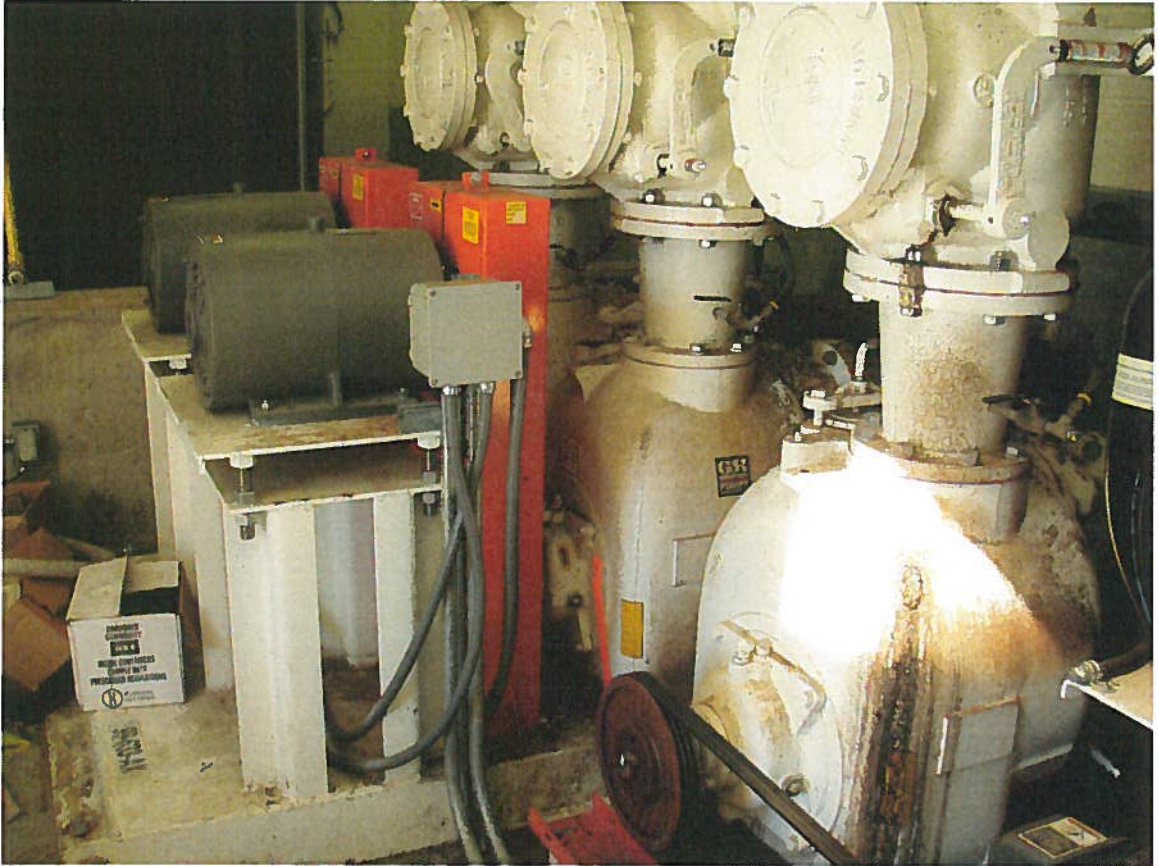
Photo no. 23 This photo was taken inside the raw sewage pump building. Shown are the suction lift sewage pumps. This building also included a chemical storage tank and feed equipment that has never been used.

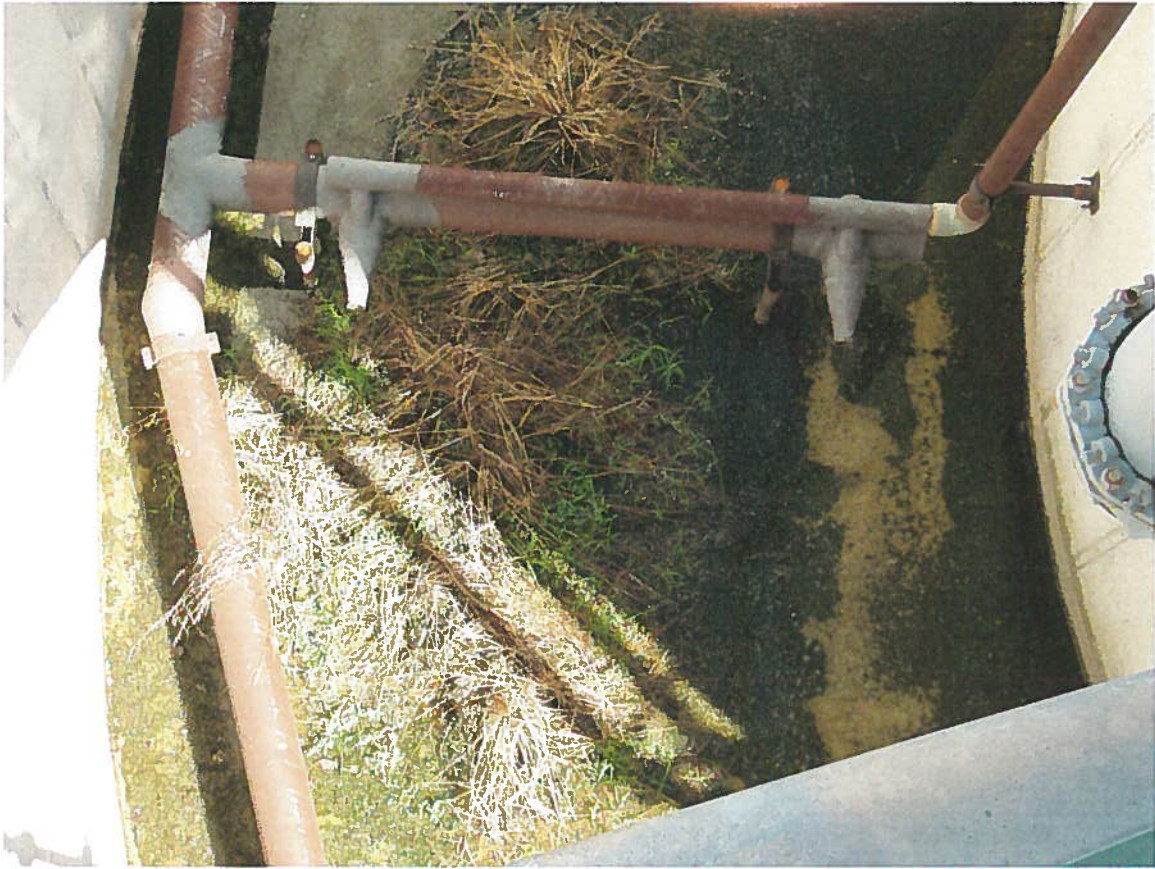
Photo no. 24 This photo was taken looking into the southeast aeration tank. The piping to the left side is connected to the motive pump which recirculates the tank liquid. The pipe at the right is an air line which feeds air into the liquid as the liquid is expelled from the nozzles. A similar arrangement is located at quarter points in the tank. This tank has not been used for about three years which has allowed vegetation to grow in the bottom supported by sludge left behind when the tank was drained.

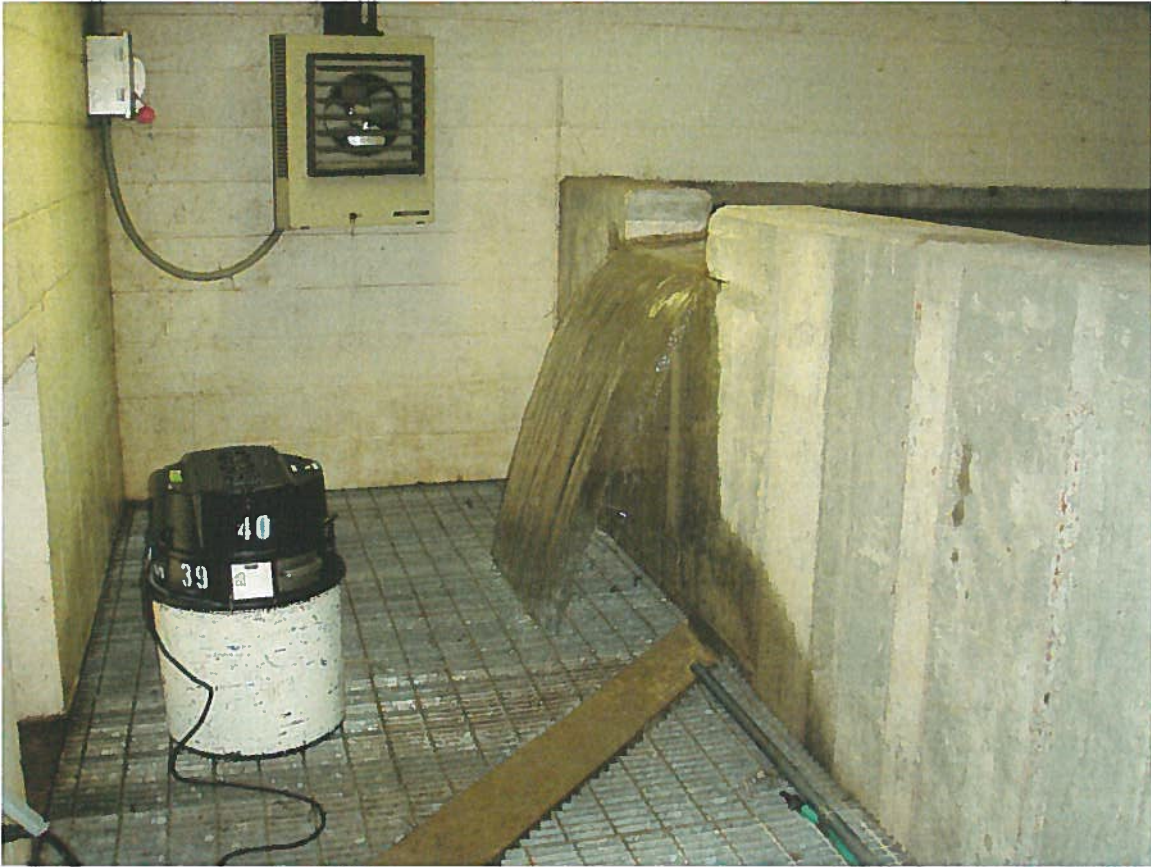
Photo no. 25 This photo was taken inside the sand filter building. The water flowing through the wall opening didn't go through the filter into the ultraviolet light disinfection channel. The flow goes directly to the facility outfall. This is a bypass since the disinfection process wasn't included as part of the treatment process.

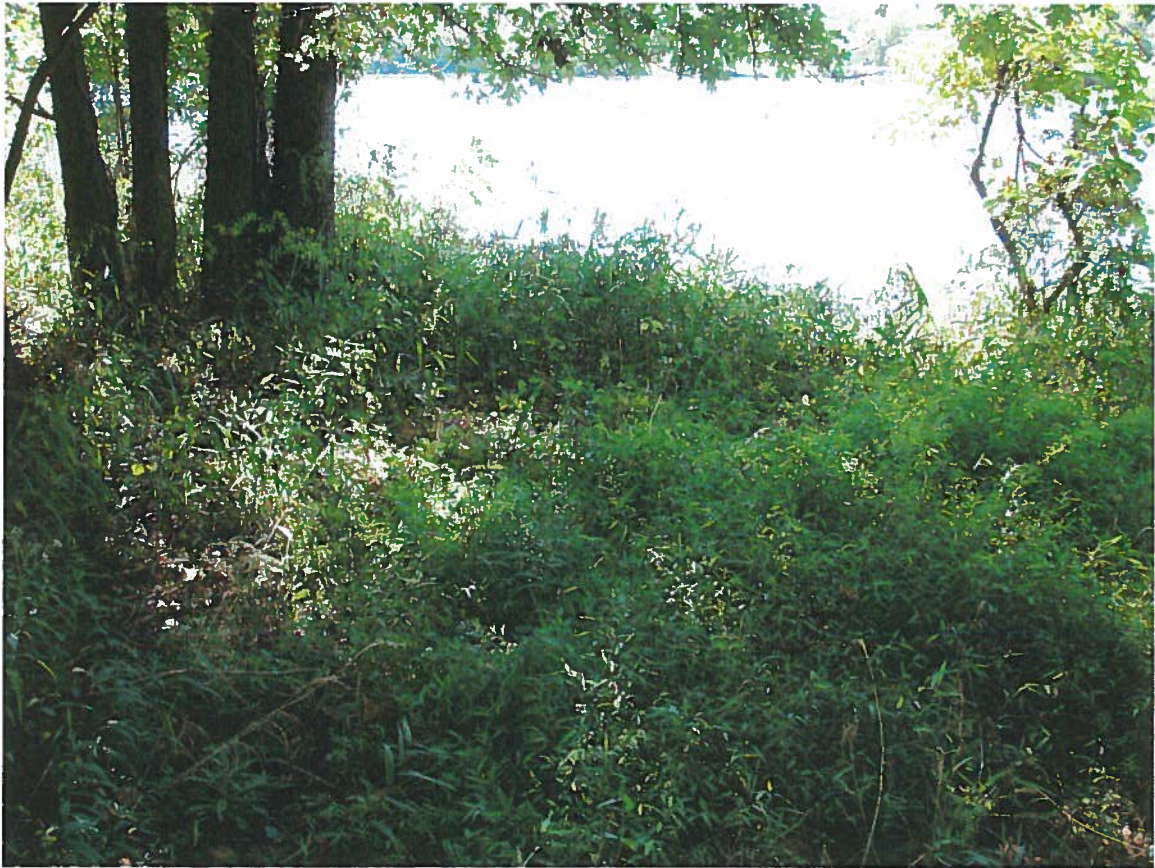
Photo no. 26 This photo looking south shows the location of the last manhole before the Lake Taneycomo submerged outfall. This would be the location of a visible sign designating the outfall as required by the NPDES permit.

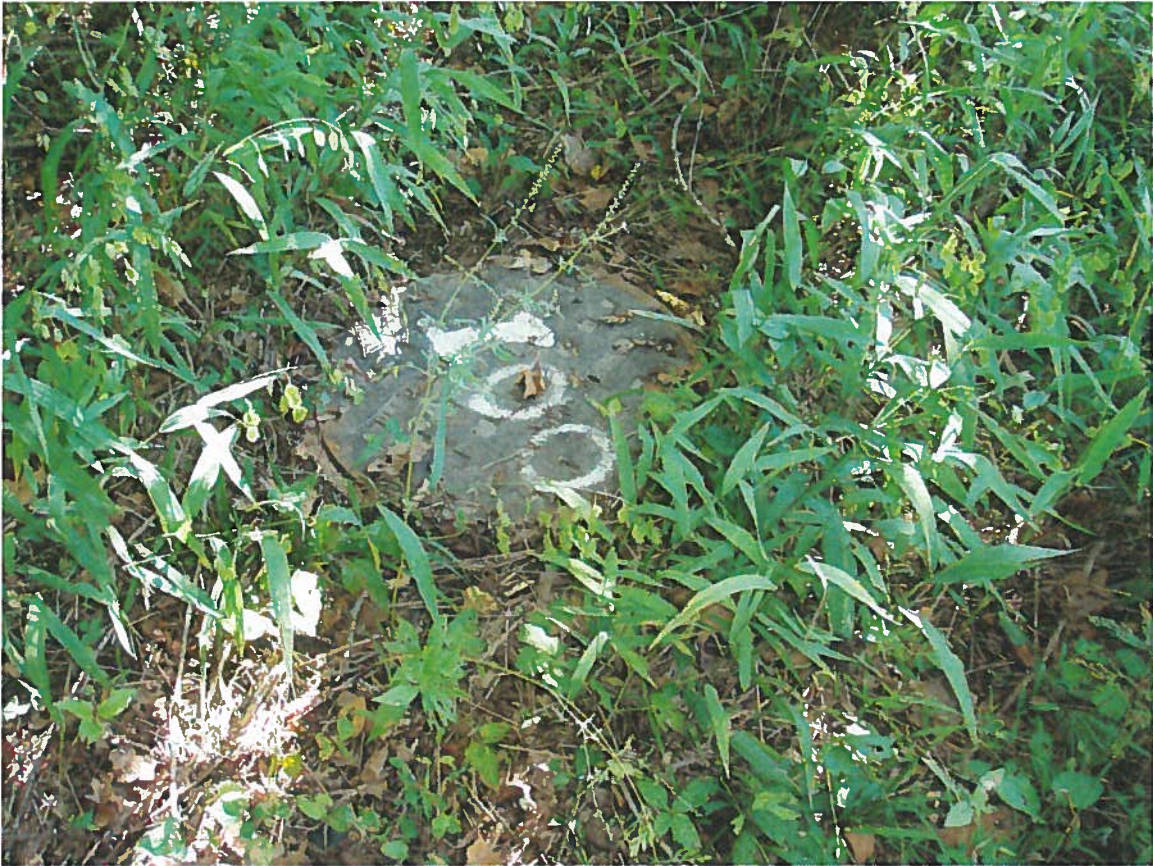
Photo no. 27 This photo shows the location of the last manhole before the Lake Taneycomo outfall. This would be the required location of a visible sign designating the outfall as required by the NPDES permit. Instead, the location is marked with an "001" indicating outfall 001 which has no real meaning to local citizens.

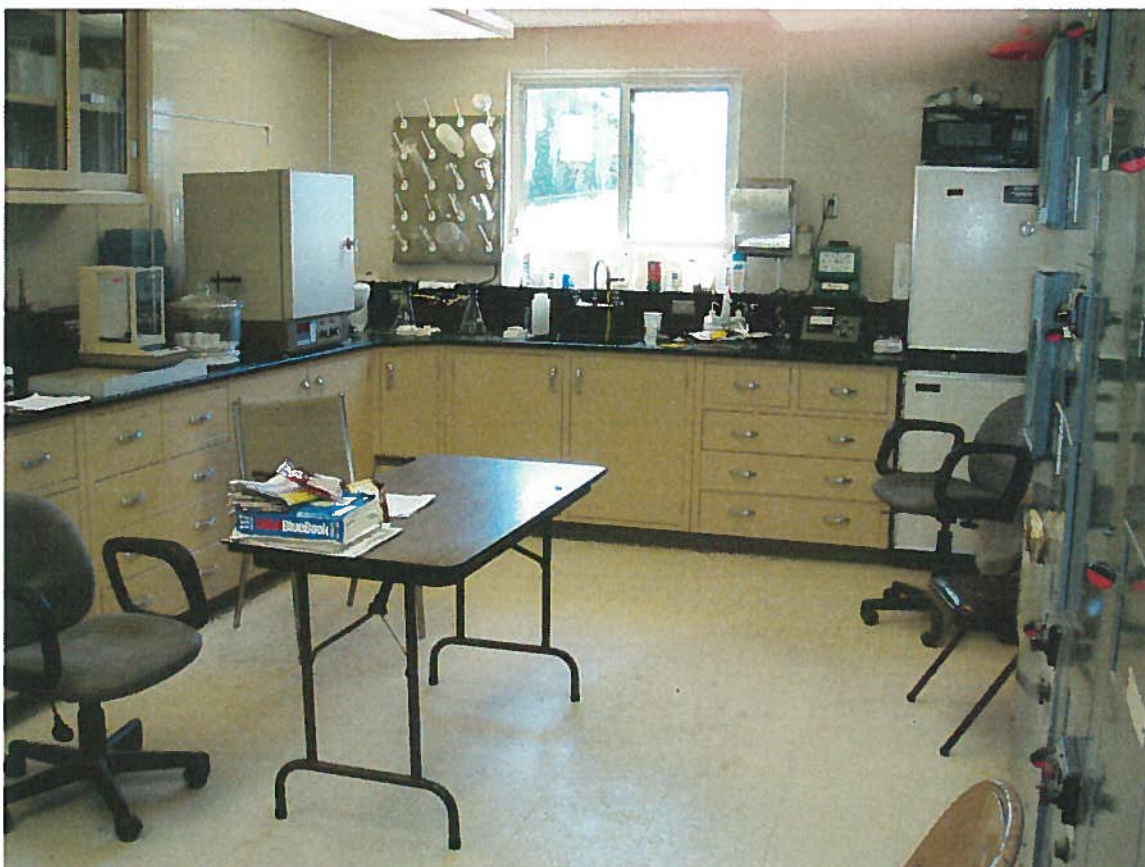
Photo no. 28 This photo shows the inside of the laboratory/control building. Commonly used laboratory testing equipment is visible. All but the dissolved oxygen meter (located underneath the time card clock) appeared to be functional.

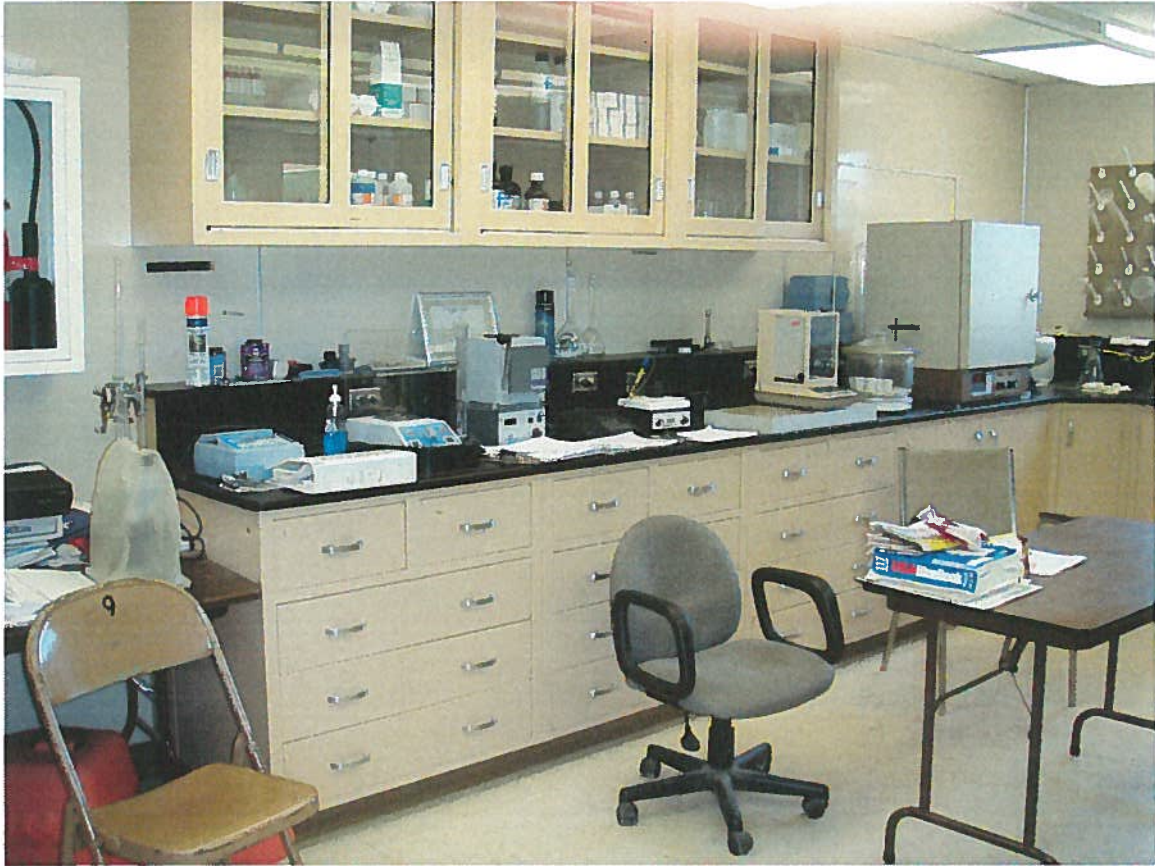
Photo no. 29 This photo shows the inside of the laboratory/control building. Commonly used laboratory testing equipment is visible. The chemicals stored in the upper cabinets were out of date (expired).

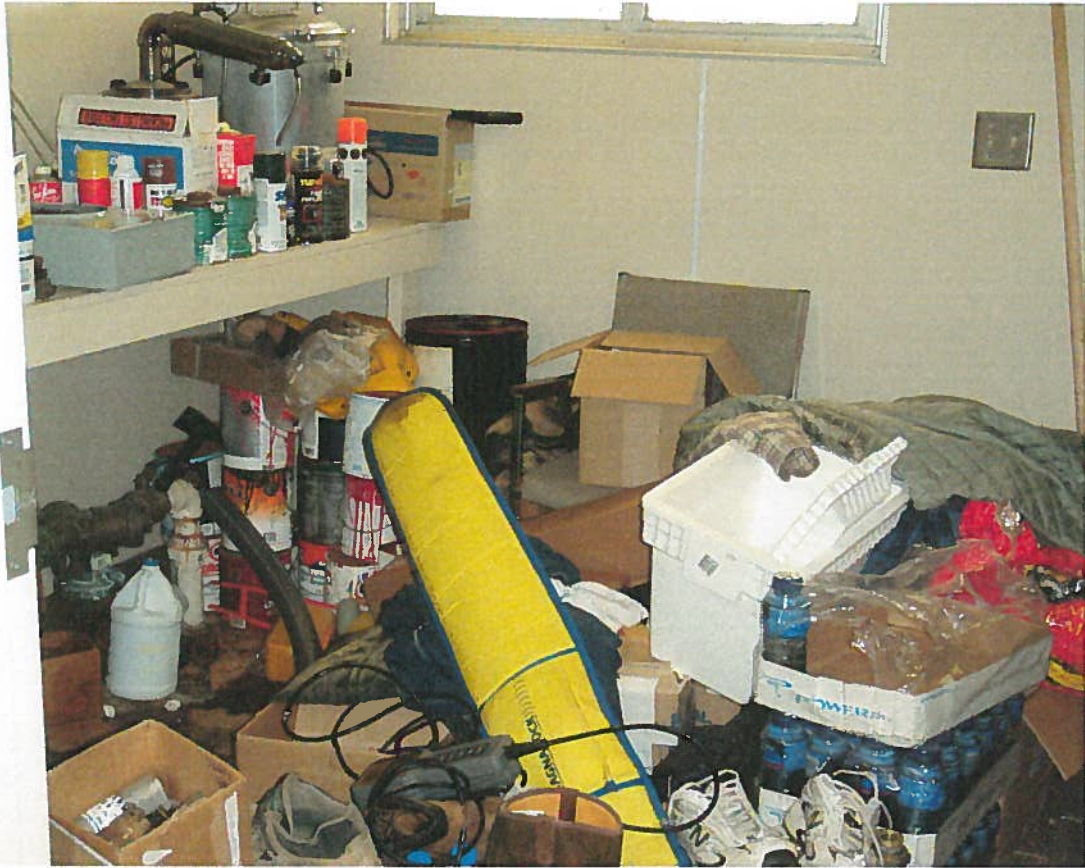
Photo no. 30 This photo shows a storage room located in the laboratory/control building. This room lacked organization and the floor clutter made moving around in the room very difficult.

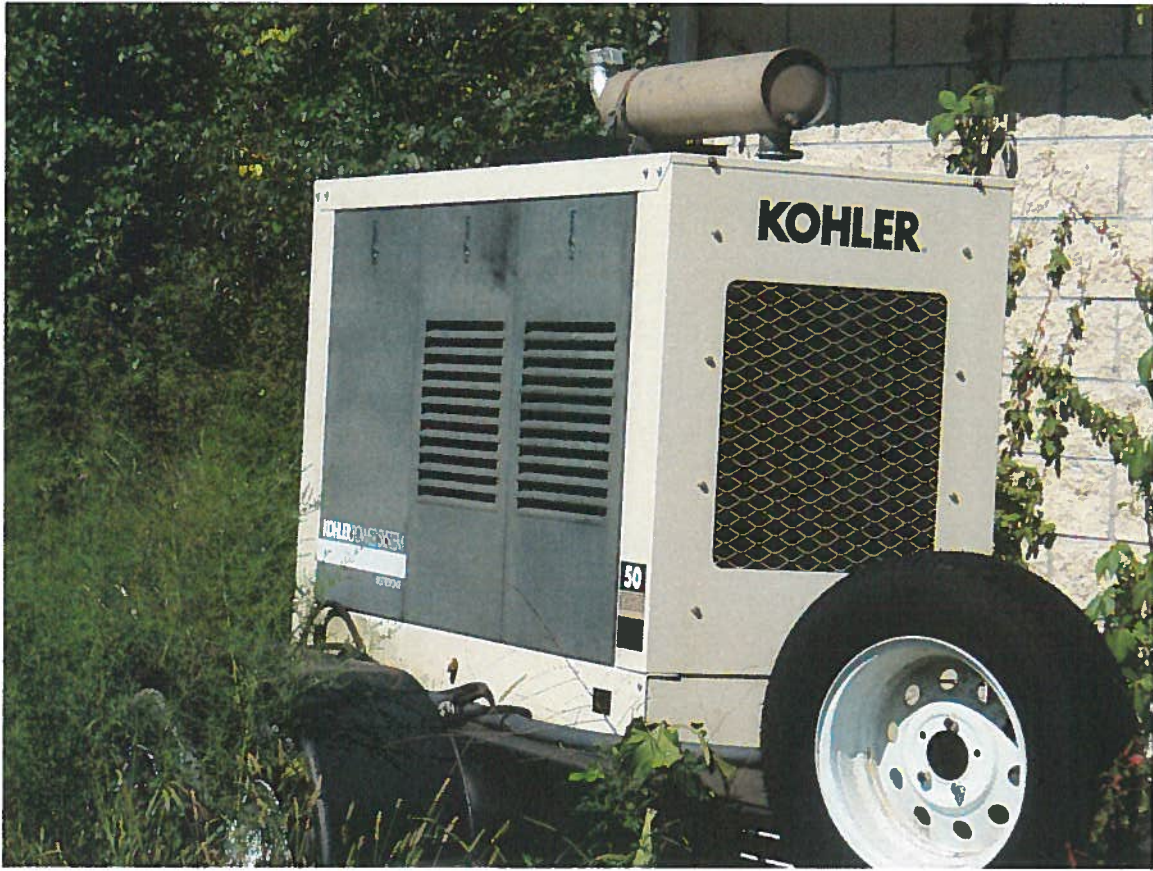
Photo no. 31 This photo was taken looking northwest from the parking area just southwest of the raw sewage pump building. Shown is a portable generator that is not used.

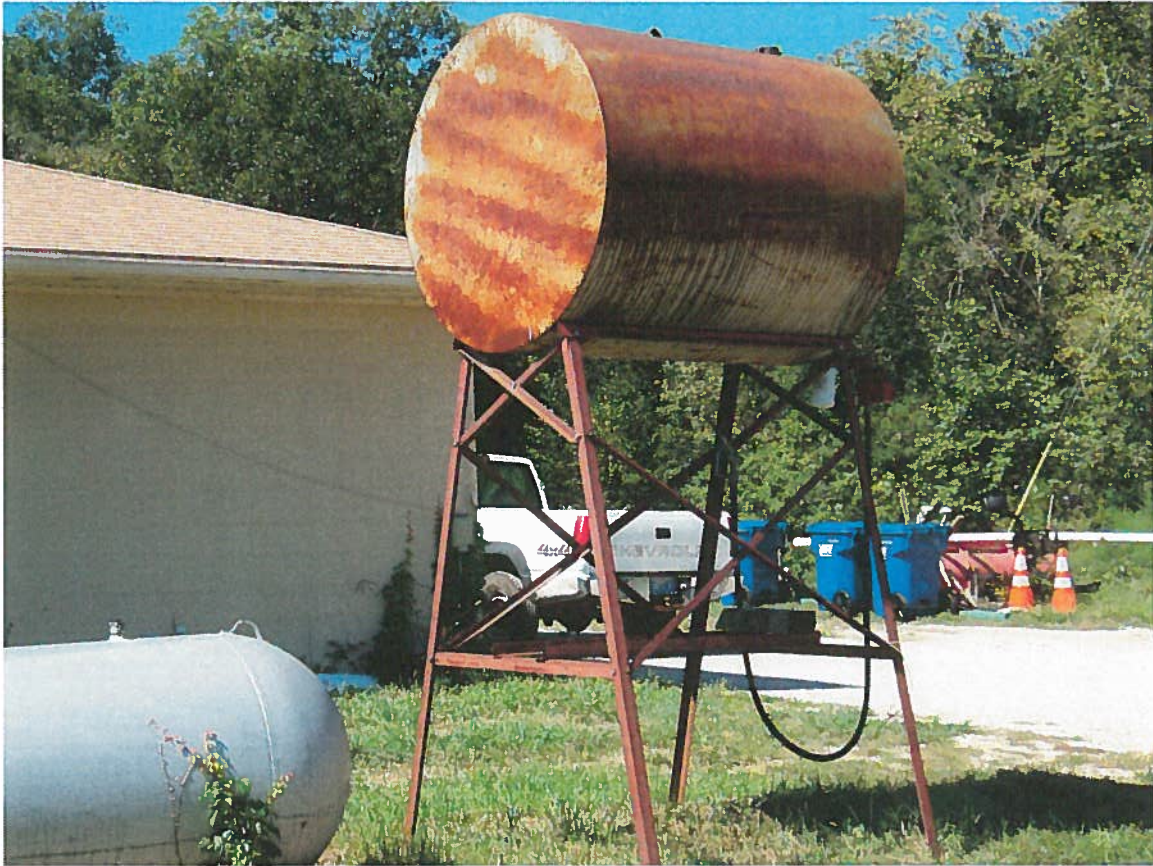
Photo no. 32 This photo was taken from the paved drying beds looking north. The building is the laboratory/control building. The elevated 500 gallon diesel fuel storage tank does not have any secondary containment.

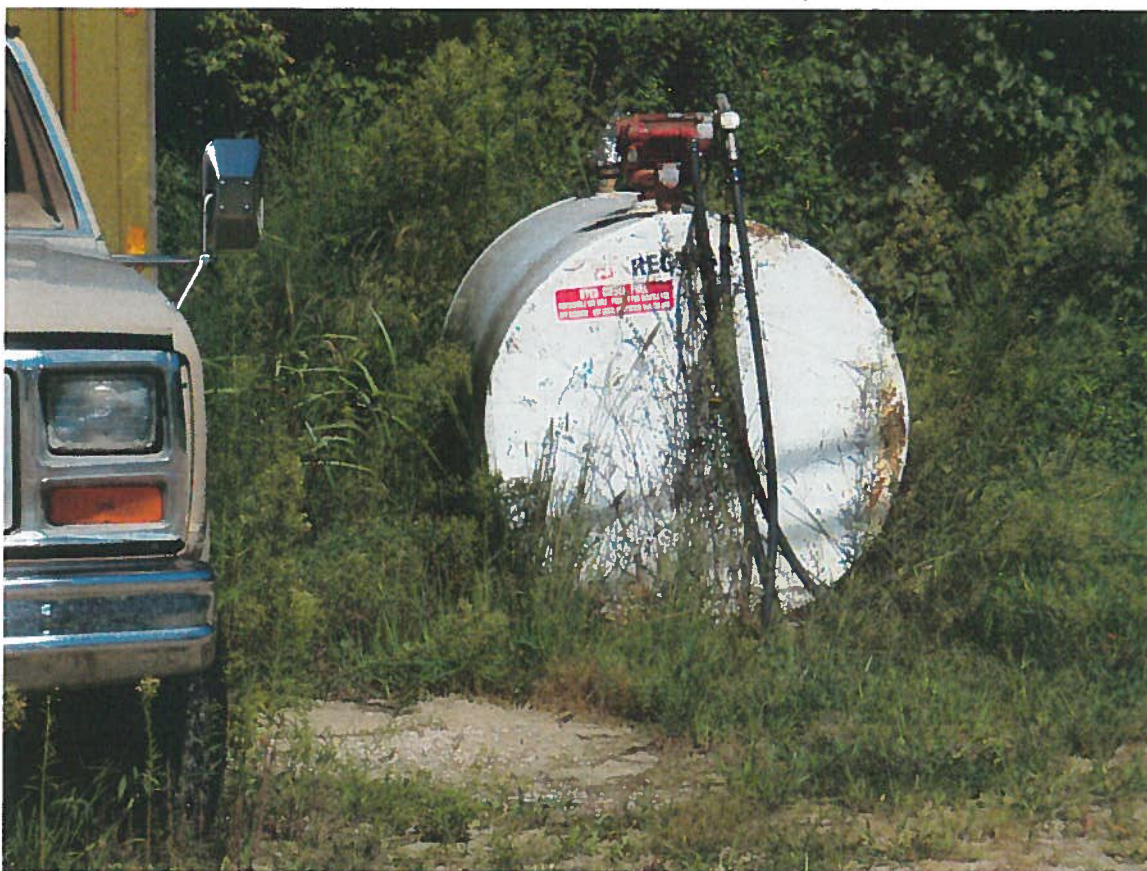
Photo no. 33 This photo was taken looking north from the parking area near the raw sewage pump building. The 300 gallon gasoline storage tank does not have secondary containment.
